EMpower System Troubleshooting Guide

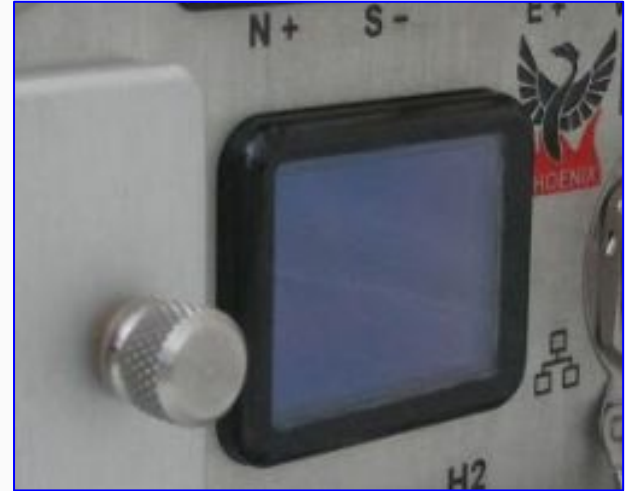
Solution:

1. Review the display
 - Make sure that a calibration configuration file was not used by mistake
2. Check to see if the SD card ran out of space
 - Check the LED indicators for this condition (*see the next page*)
3. Check your configuration file and ensure that there were no schedules that could have stopped the recording

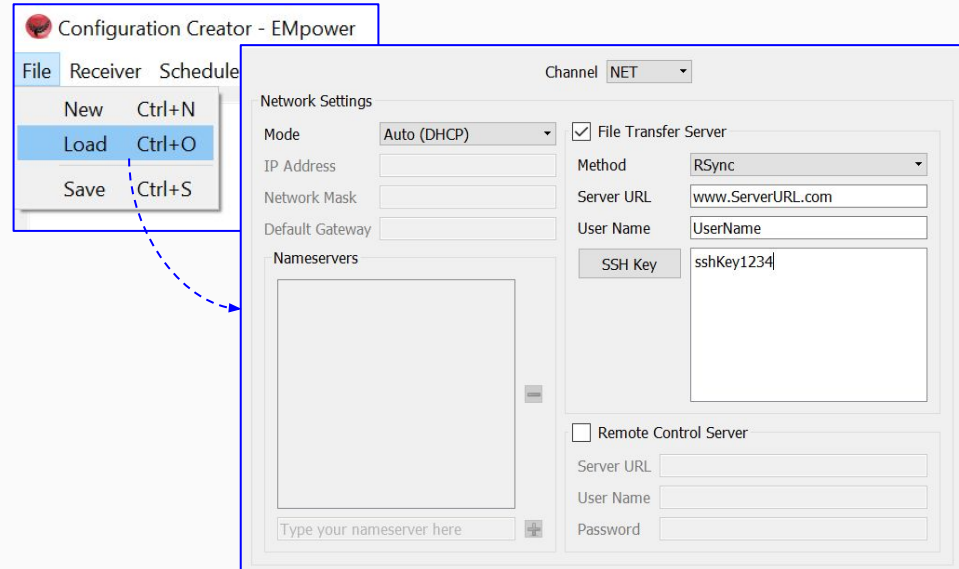
SD ■ ■

```
REC ERRORS
-----
INVALID CONFIG
NETWORK
SETTINGS INVALID
```

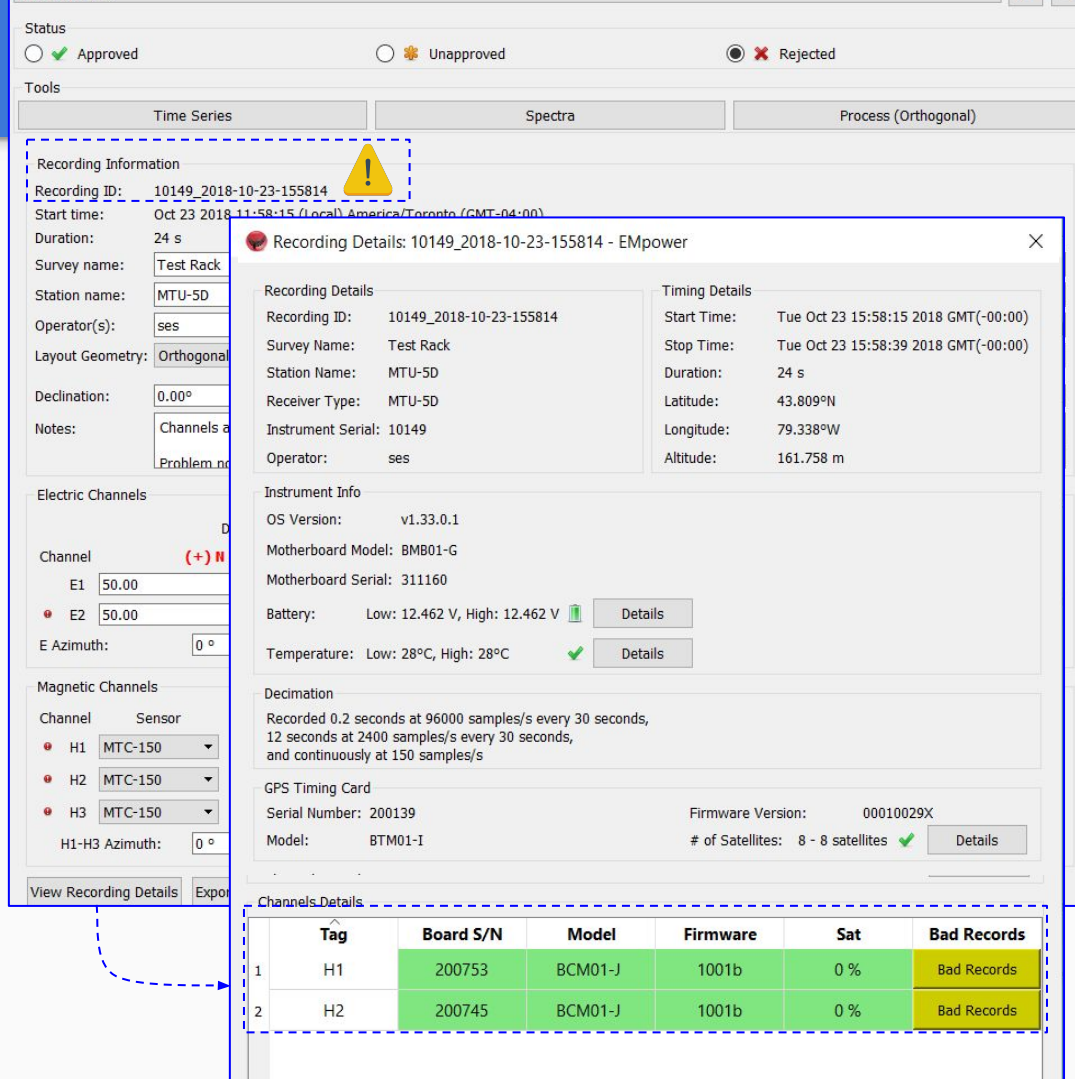
Status: Approved Unapproved Rejected

Tools: Time Series Spectra Process (Orthogonal)
