EMpower System Troubleshooting Guide

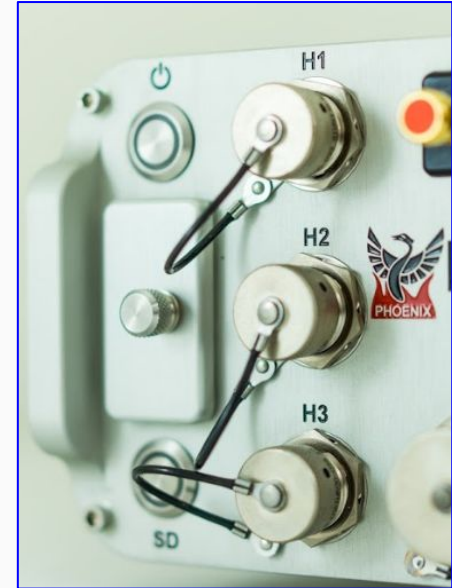
Equipment Unexpected turn off

Receiver powers on briefly, and powers off right away, or when returning to the site the equipment is off

1. Check that the **Battery** measures 12V with a voltmeter after powering on
 - *Check the recording details of the last recording to see if the battery voltage reached low levels and turned off the receiver*
2. Check if the battery cable is still attached
 - *Animals might have chewed through it or disconnected it*
 - *A damaged cable (internally broken or old) can cause an intermittent power failure during recording*
3. The instrument might have gotten too hot and entered protection mode
 - *Check the recording details of the last recording to see if the temperature reached invalid levels*
4. The instrument might have received a momentary spike of high current through the electric sensor or ground post
 - *Check that the **SD Card** is still healthy, and check the last part of the last recording for saturation*

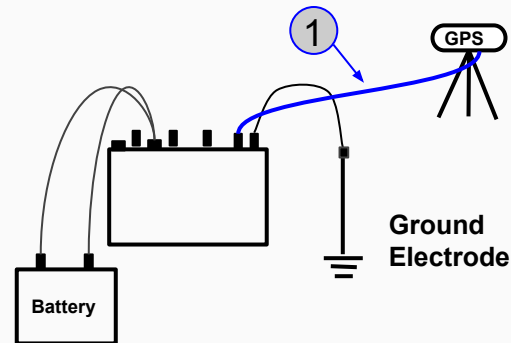
Use the SD button to navigate in the on-screen display

Starting Acquiring GPS Ready

In most cases, the Receiver takes only a few minutes to synchronize to the GPS signal. However, under certain conditions, the synchronization could take longer (*see info note below*). Meanwhile the warning **"GPS: 0 [--]"**, appears on the receiver display.

1. Reposition the antenna for a clear view of the sky
 - Check the condition of the GPS antenna cable, and replace it if damaged
 - Ensure that there is a clear line-of-sight between the GPS antenna and the sky
 - Test with an antenna and cable from another receiver
2. Wait until the Power button turns blue

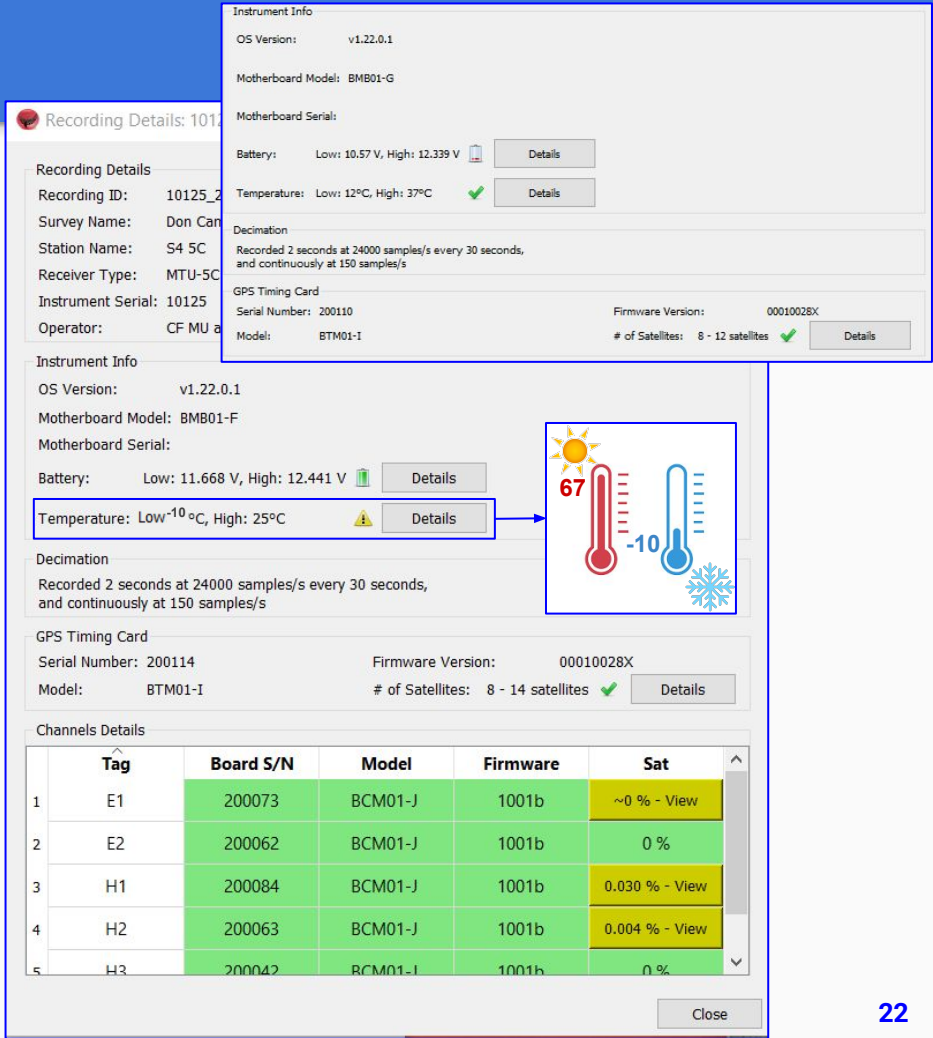
The screenshot displays a software interface for instrument health monitoring. It is divided into several sections:

- Recording Details:** Shows recording ID (10125_2), survey name (Don Can), station name (S4 5C), receiver type (MTU-5C), instrument serial (10125), and operator (CF MU a).
- Instrument Info:** Shows OS Version (v1.22.0.1), Motherboard Model (BMB01-F), Motherboard Serial, Battery (Low: 11.668 V, High: 12.441 V), and Temperature (Low: -10 °C, High: 25 °C). A warning icon is present next to the temperature reading. A callout box highlights the temperature section, showing a thermometer with 67 and -10, and a snowflake icon.
- Decimation:** Recorded 2 seconds at 24000 samples/s every 30 seconds, and continuously at 150 samples/s.
- GPS Timing Card:** Serial Number: 200114, Firmware Version: 00010028X, Model: BTM01-I, # of Satellites: 8 - 14 satellites.
- Channels Details:** A table listing channels with columns for Tag, Board S/N, Model, Firmware, and Sat.

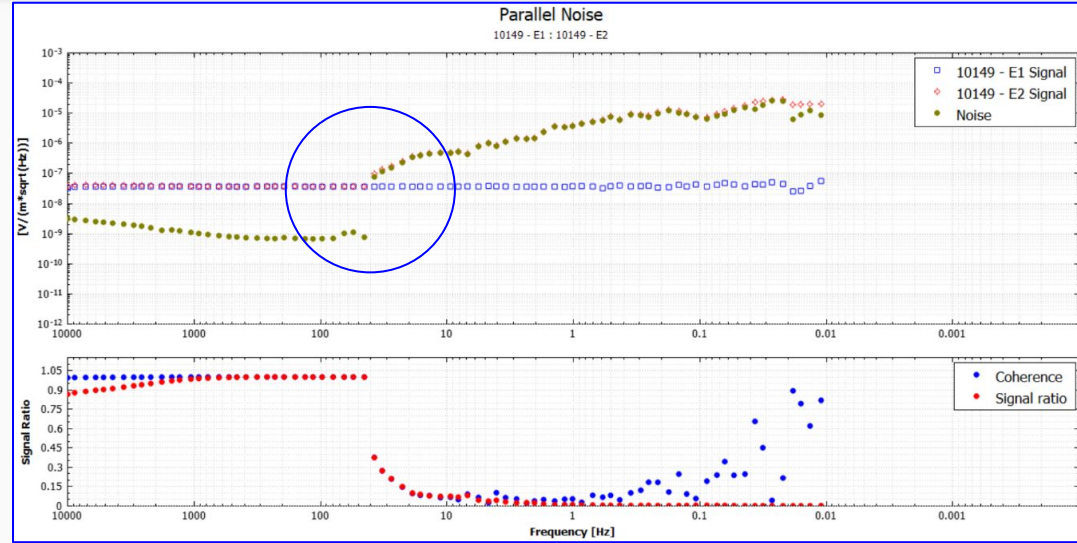
This problem could be caused when something touches the receiver E-line binding post during the recording process, review the Time Series and find the E-line affected.

Review the installation and keep cables flat on the ground, not draped over plants or over the receiver.
