Upgrade Receiver Firmware

2. Before beginning
3. Upgrading the Receiver Firmware
4. After the Upgrade
5. Troubleshooting
7. Technical Support Contact

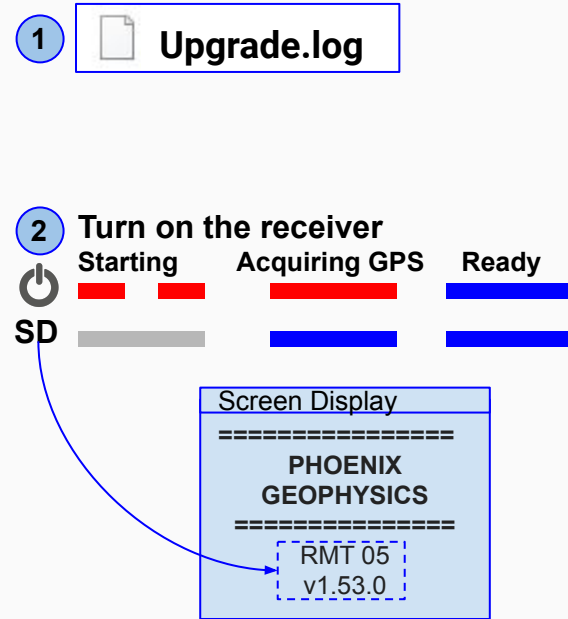
2. Turn on the receiver and verify that the upgrade process was completed and review the OS version
