# EMpower System Troubleshooting Guide

Equipment Failure to start .....	2
Equipment Unexpected turn off .....	3
No SD Card .....	4
SD CARD Wrong Format .....	5
SD CARD format is not compatible with the Receiver OS ..	6
SD Card Read Only .....	7
GPS Not Detected .....	8
Failure to Record .....	9
SD Card is Full .....	10
Configuration file issues .....	11
Invalid Configuration Network .....	12
Remote Control Problem Connection .....	13
Connection Problems .....	14
Cable Not Detected .....	15
Channels Damaged / Not Found .....	16
License Activation .....	17
Unusual Contact Resistance .....	18
Magnetic Sensor Detection .....	19
Saturated Frames .....	20
Bad Records .....	21
Instrument Health .....	22
Missing Sensor Calibration .....	23
Bad PNT curve .....	24
Technical Support Contact .....	25

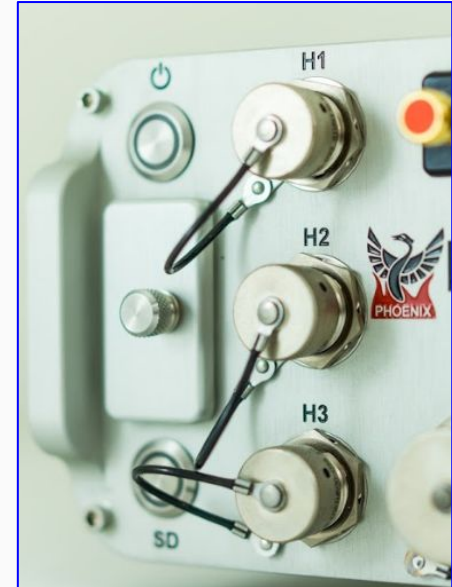
Receiver powers on briefly, and powers off right away, or when returning to the site the equipment is off

1. Check that the **Battery** measures 12V with a voltmeter after powering on
  - Check the recording details of the last recording to see if the battery voltage reached low levels and turned off the receiver
2. Check if the battery cable is still attached
  - Animals might have chewed through it or disconnected it
  - A damaged cable (internally broken or old) can cause an intermittent power failure during recording
3. The instrument might have gotten too hot and entered protection mode
  - Check the recording details of the last recording to see if the temperature reached invalid levels
4. The instrument might have received a momentary spike of high current through the electric sensor or ground post
  - Check that the **SD Card** is still healthy, and check the last part of the last recording for saturation

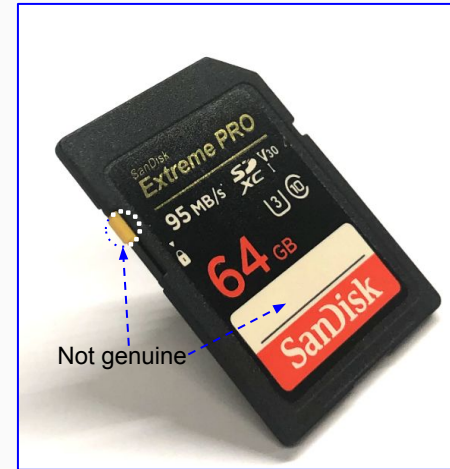
### REC ERRORS

=====  
SD CARD IS DAMAGED  
CORRUPTED OR  
THE WRONG FORMAT

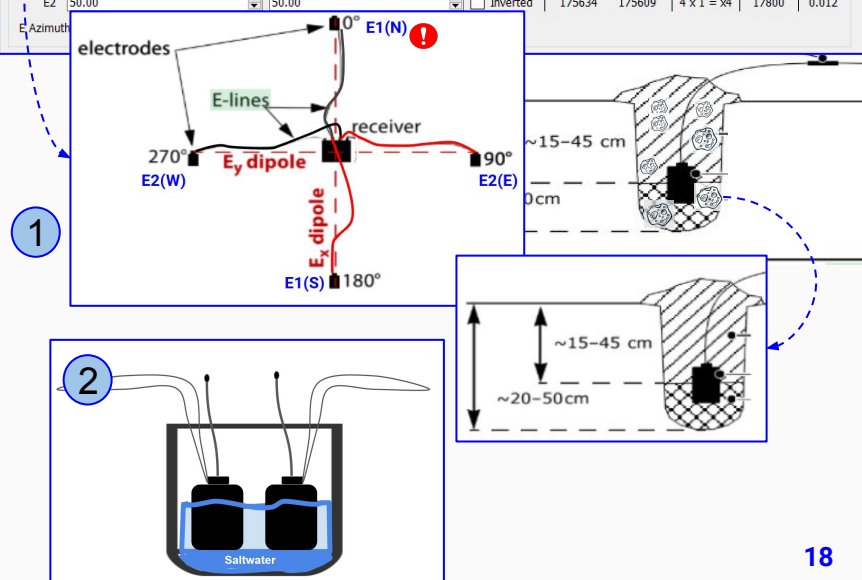
Electric Channels

Channel	Distance (m) to GND		Polarity	Resistance ( $\Omega$ )		Gain	LPF [Hz]	DC [V]
	(+) N / E	(-) S / W		(+) N / E	(-) S / W			
E1	50.00	50.00	<input type="checkbox"/> Inverted	175831	175789	4 x 1 = x4	17800	-0.012
E2	50.00	50.00	<input type="checkbox"/> Inverted	175634	175609	4 x 1 = x4	17800	0.012

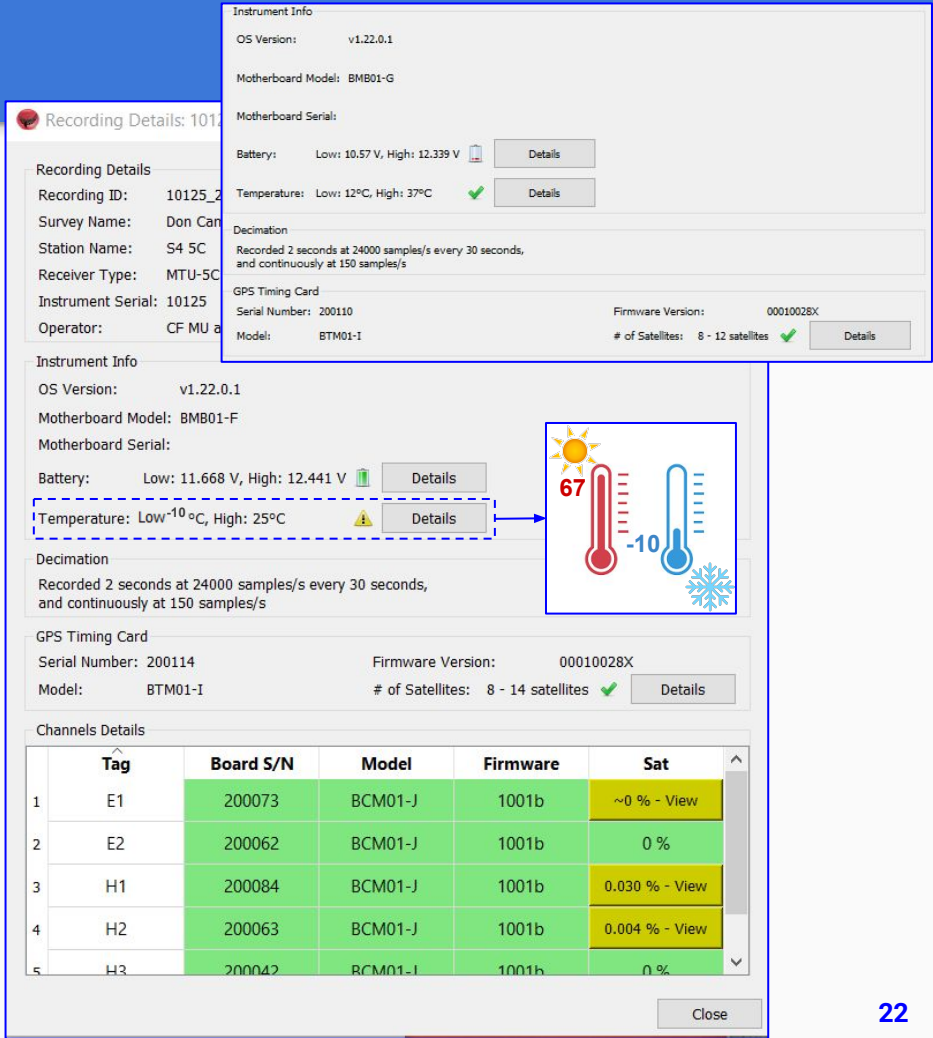
The screenshot displays the 'Recording Details' and 'Instrument Info' sections of a monitoring application. A warning icon is present next to the temperature reading.

**Recording Details:**

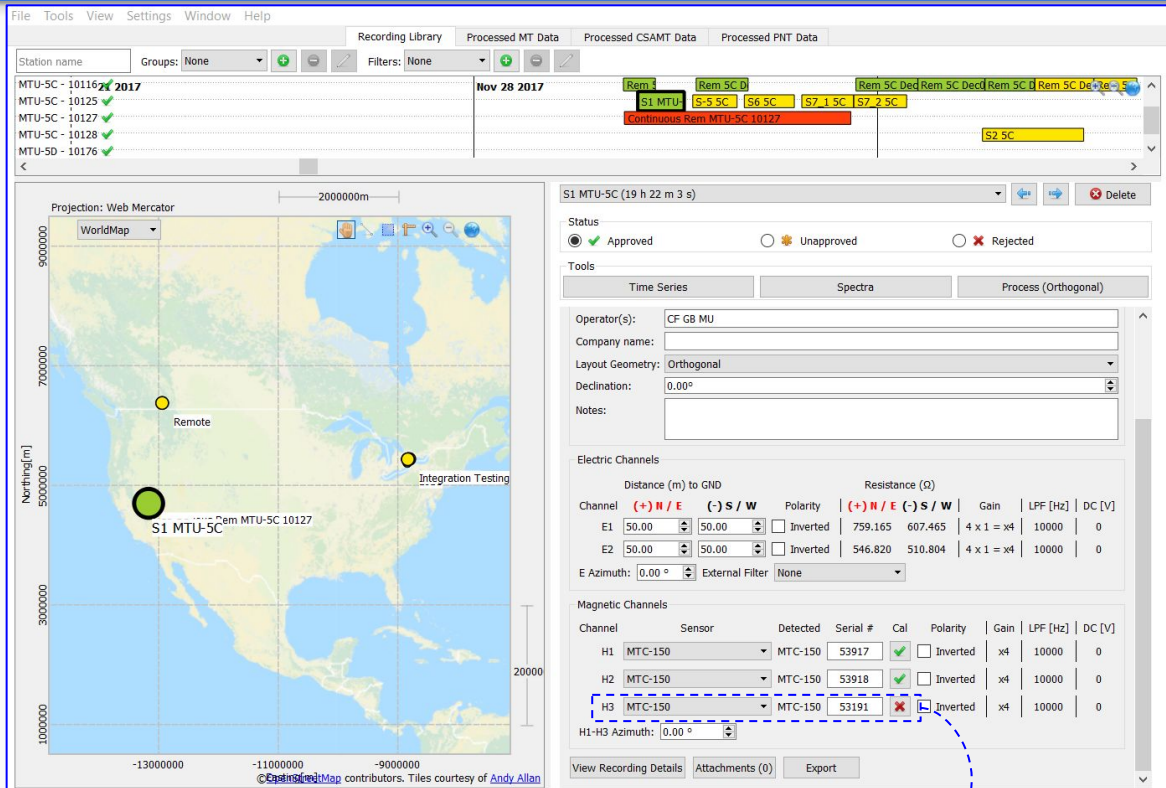
Station name	Groups	Filters	Cal
MTU-5C - 101162	None	None	✓
MTU-5C - 10125	None	None	✓
MTU-5C - 10127	None	None	✓
MTU-5C - 10128	None	None	✓
MTU-5D - 10176	None	None	✓
S1 MTU-5C	None	None	✗

Channel	(+) N / E	(-) S / W	Polarity	(+) N / E	(-) S / W	Gain	LPF [Hz]	DC [V]
E1	50.00	50.00	<input type="checkbox"/> Inverted	759.165	607.465	4 x 1 = x4	10000	0
E2	50.00	50.00	<input type="checkbox"/> Inverted	546.820	510.804	4 x 1 = x4	10000	0

No matching calibration found

If a red X is displayed in the **Cal** column of a magnetic channel, the calibration file for that sensor serial number has not been found
