# EMpower System Troubleshooting Guide

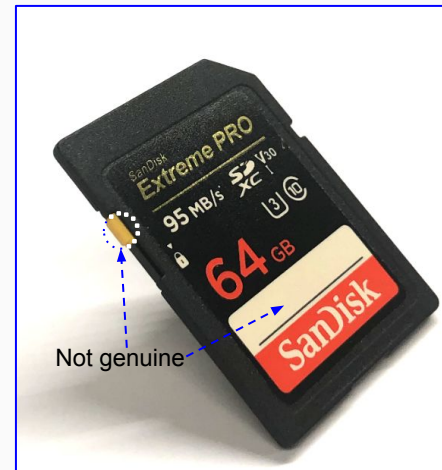
=====  
SD CARD IS DAMAGED  
CORRUPTED OR  
THE WRONG FORMAT

### REC ERRORS
